Dam safety monitoring of Qyrsaq dam in Vau Dejës HPP, Albania

E. Kaçurri, E. Qosja, E. Nuri
KESH sh.a, Tirana, Albania

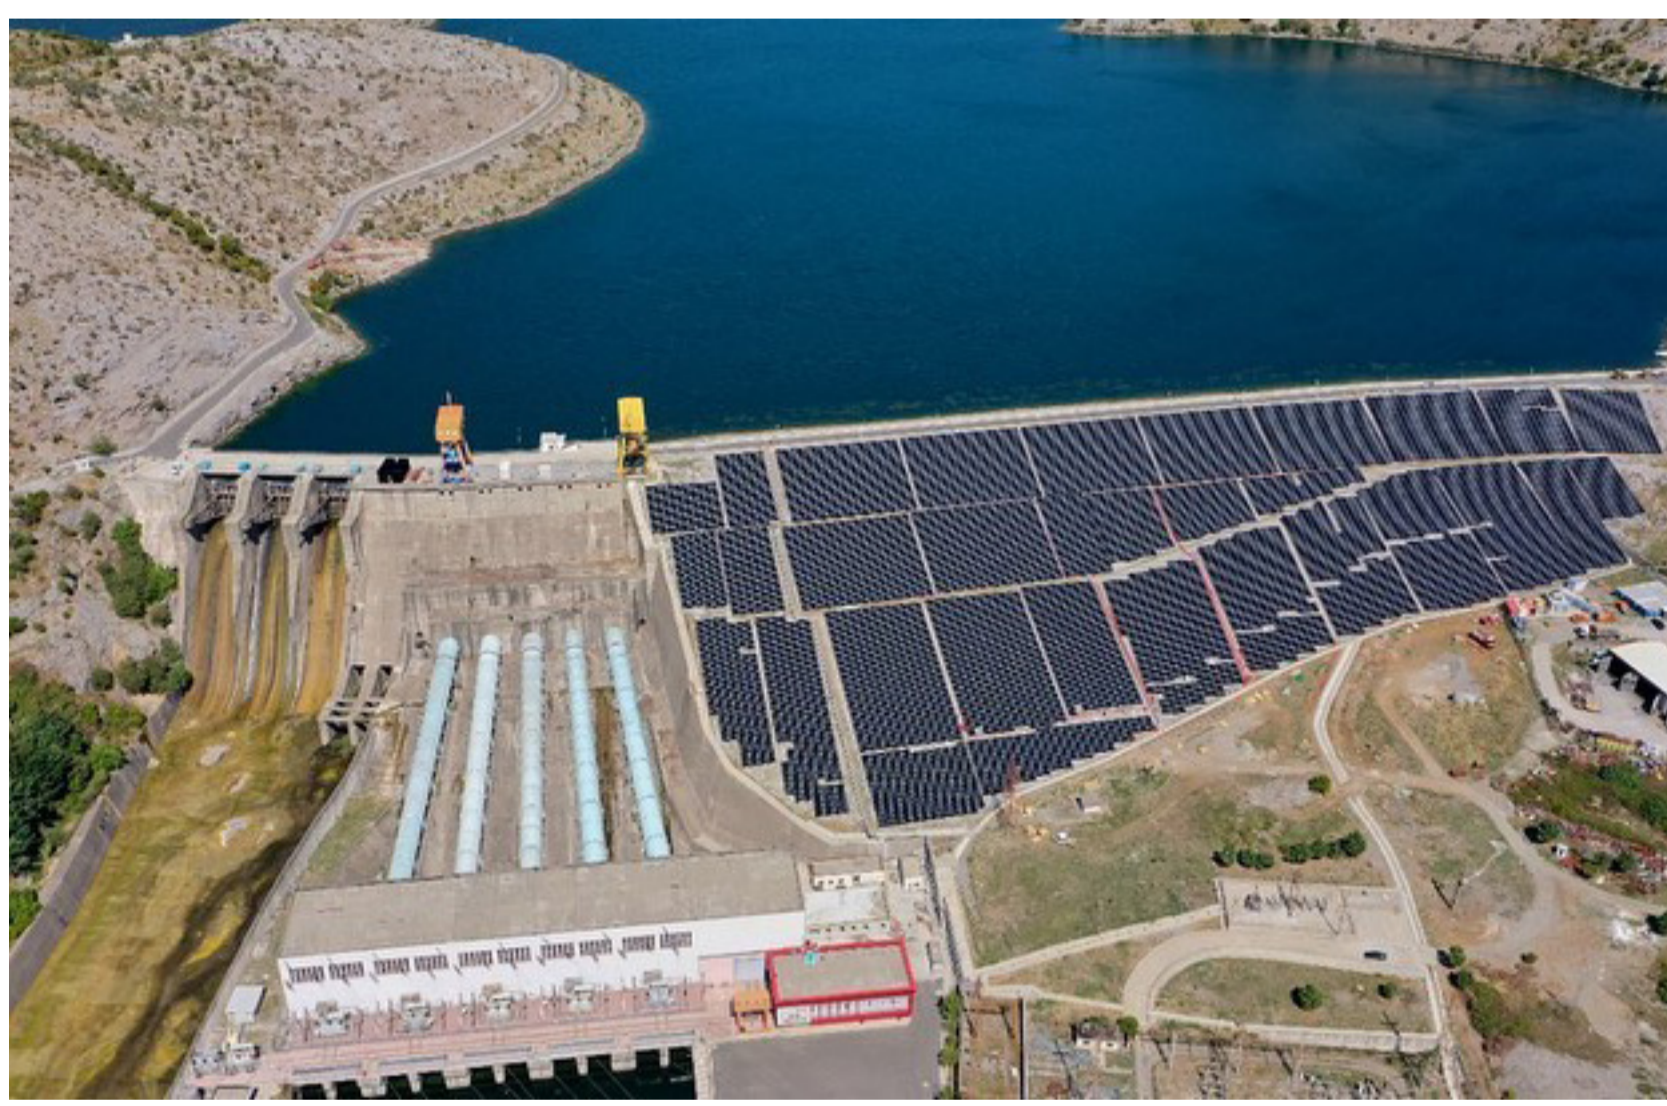
Qyrsaq Dam has been operating since 1971. This dam is 54 m high and the dam body volume is about 1.8 million m³. The maximum volume of water in the reservoir is 580 million m³. There are three spillway gates, each measuring 12x12.3 m, with a discharging capacity of 3,900 m³/sec. Two bottom outlet gates, each measuring 4.0x6.5 m, have never been opened during more than 50 years of operation.

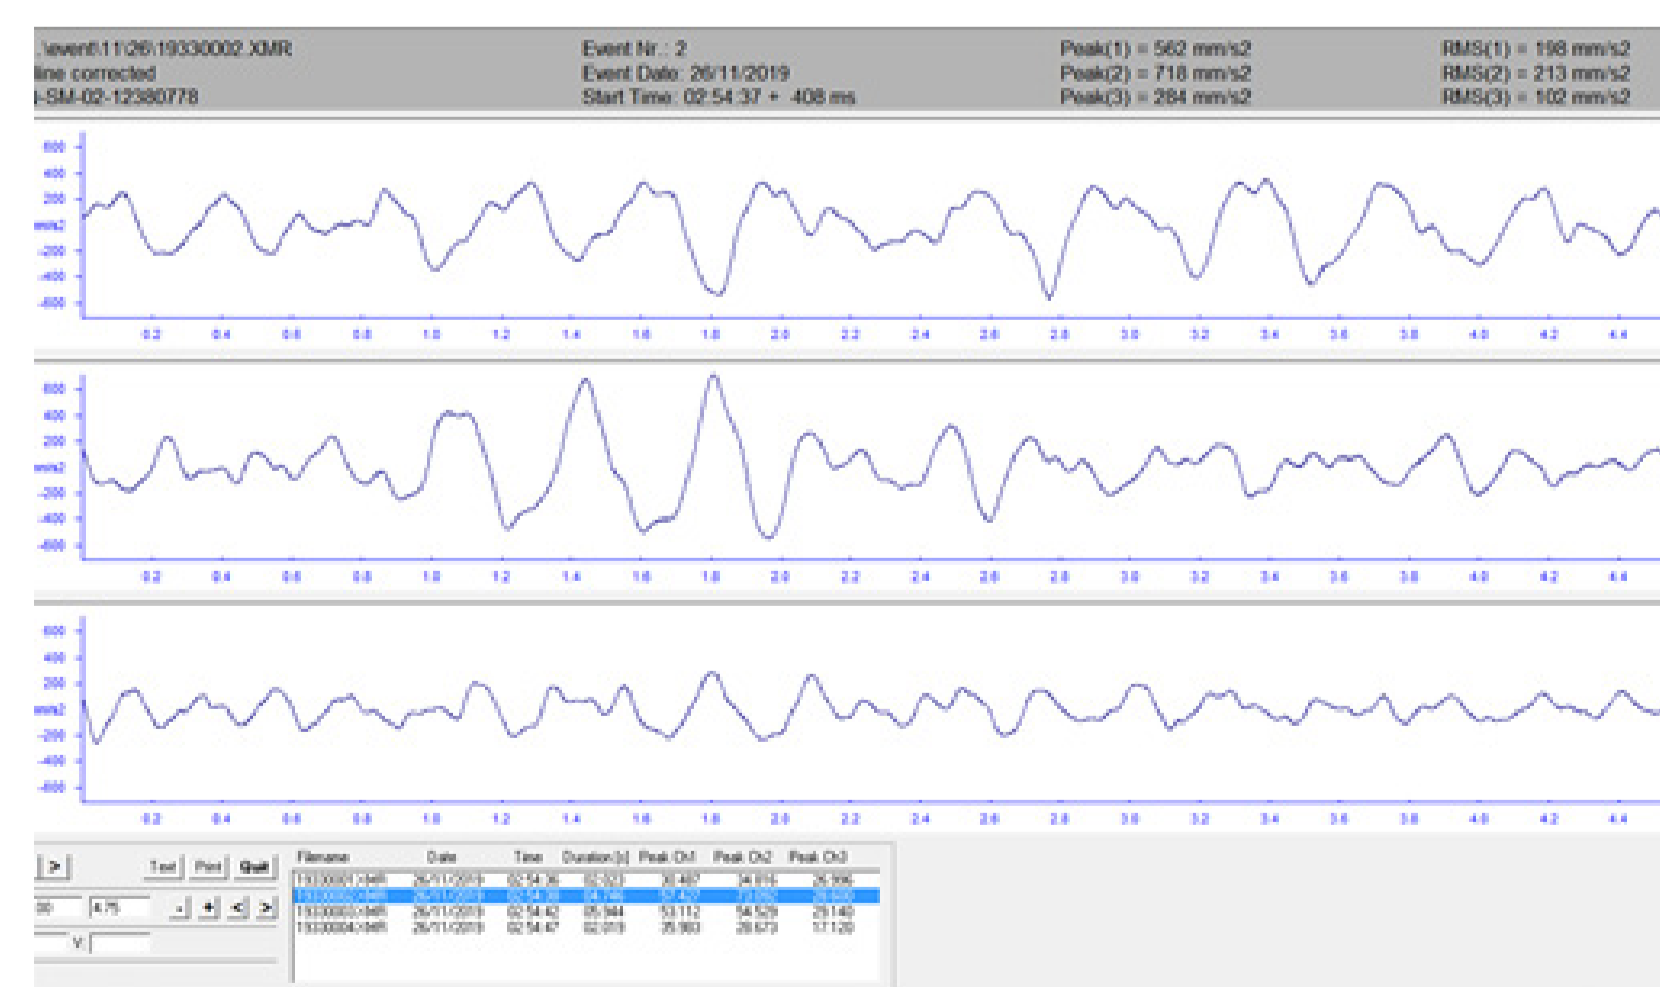
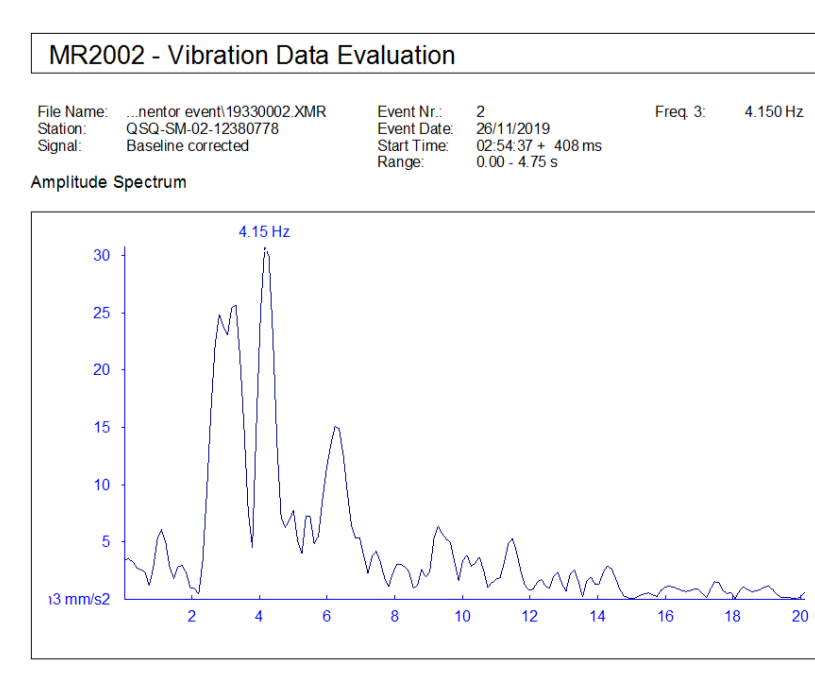
Very interesting was the seismic monitoring of the crest of Qyrsaq dam considering the two different parts of this dam. As expected, the largest PGA of 717 mm/sec² occurred on the rockfill part compared to the gravity concrete part with a PGA of 245 mm/sec². The difference in the material of the dam makes the structure react and absorb the dynamic seismic action in a different way.

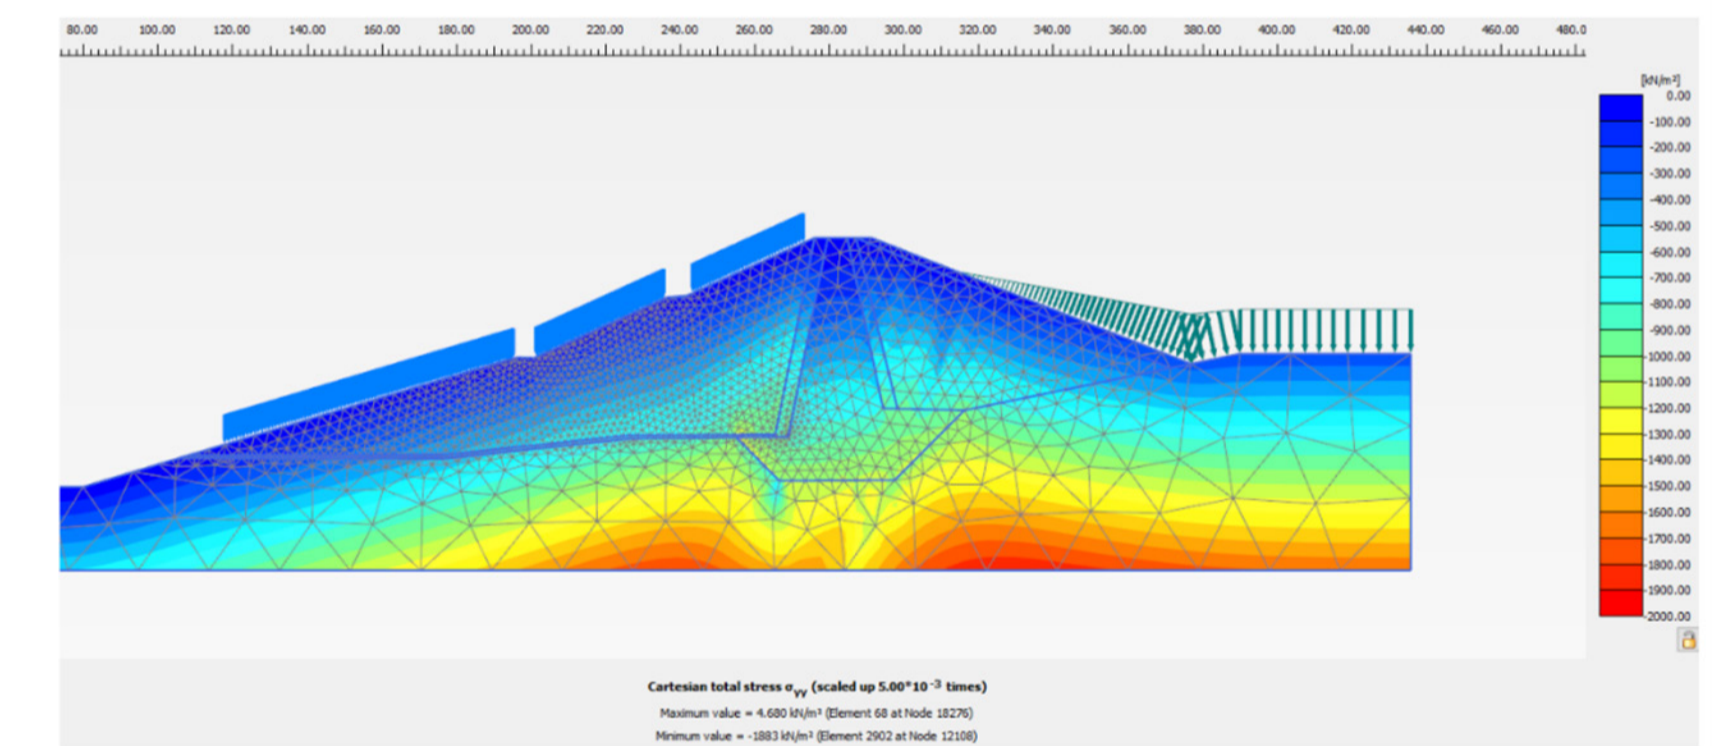
The new challenge in the monitoring process appeared to us after the installation of photovoltaic panel plants on the dam body. There are more than 10,000 solar panel modules installed producing 5.14 MW-peak. Some geodetic monuments can be reached by at least two of them, and this is enough for monitoring. Even though the weight of panels is low, we insisted on calculating the stress that would be created in the dam body with this new structure on it. It has been revealed that the stress forces in the dam body are as shown in the graph below.
