Geological hazard evaluation for dams constructed at Drin valley

Author(s): Skender Allkja, Ardita Malaj

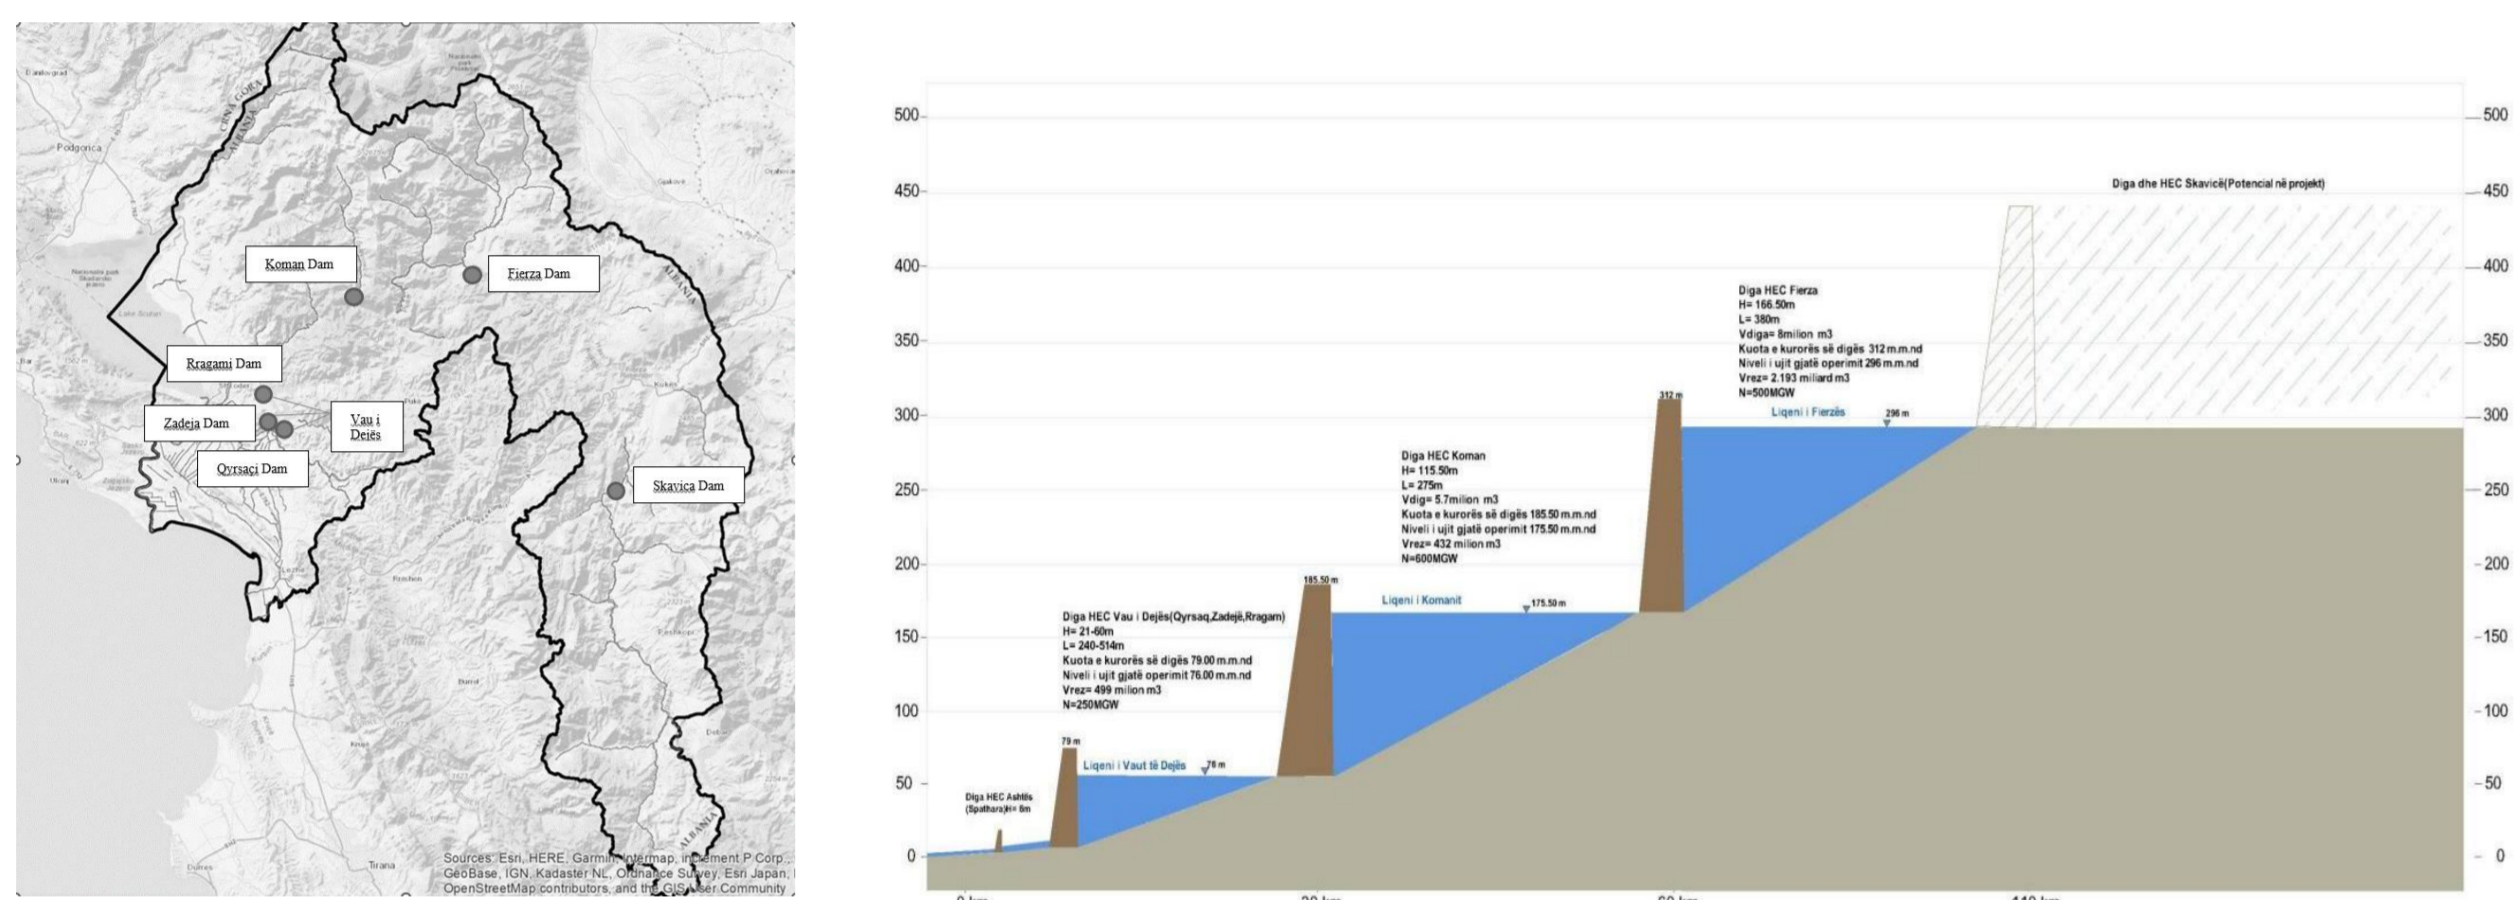
Fig. 1: General overview of dam location, types, technical data representation

The Drin is a key component of the Albanian economy. Other than hydro power production, the cascade provides a variety of public services including tourism, water sport/transport, aquaculture, fishing, flood protection, and lately has been considered solar energy production as well. It has a basin area of 11,756 km², and an estimated discharge of 352 m³/s. Three hydropower facilities produce most of Albania's electricity power, named Fierza, Komani, Vau i Dejes, with 6 dams constructed over this cascade.

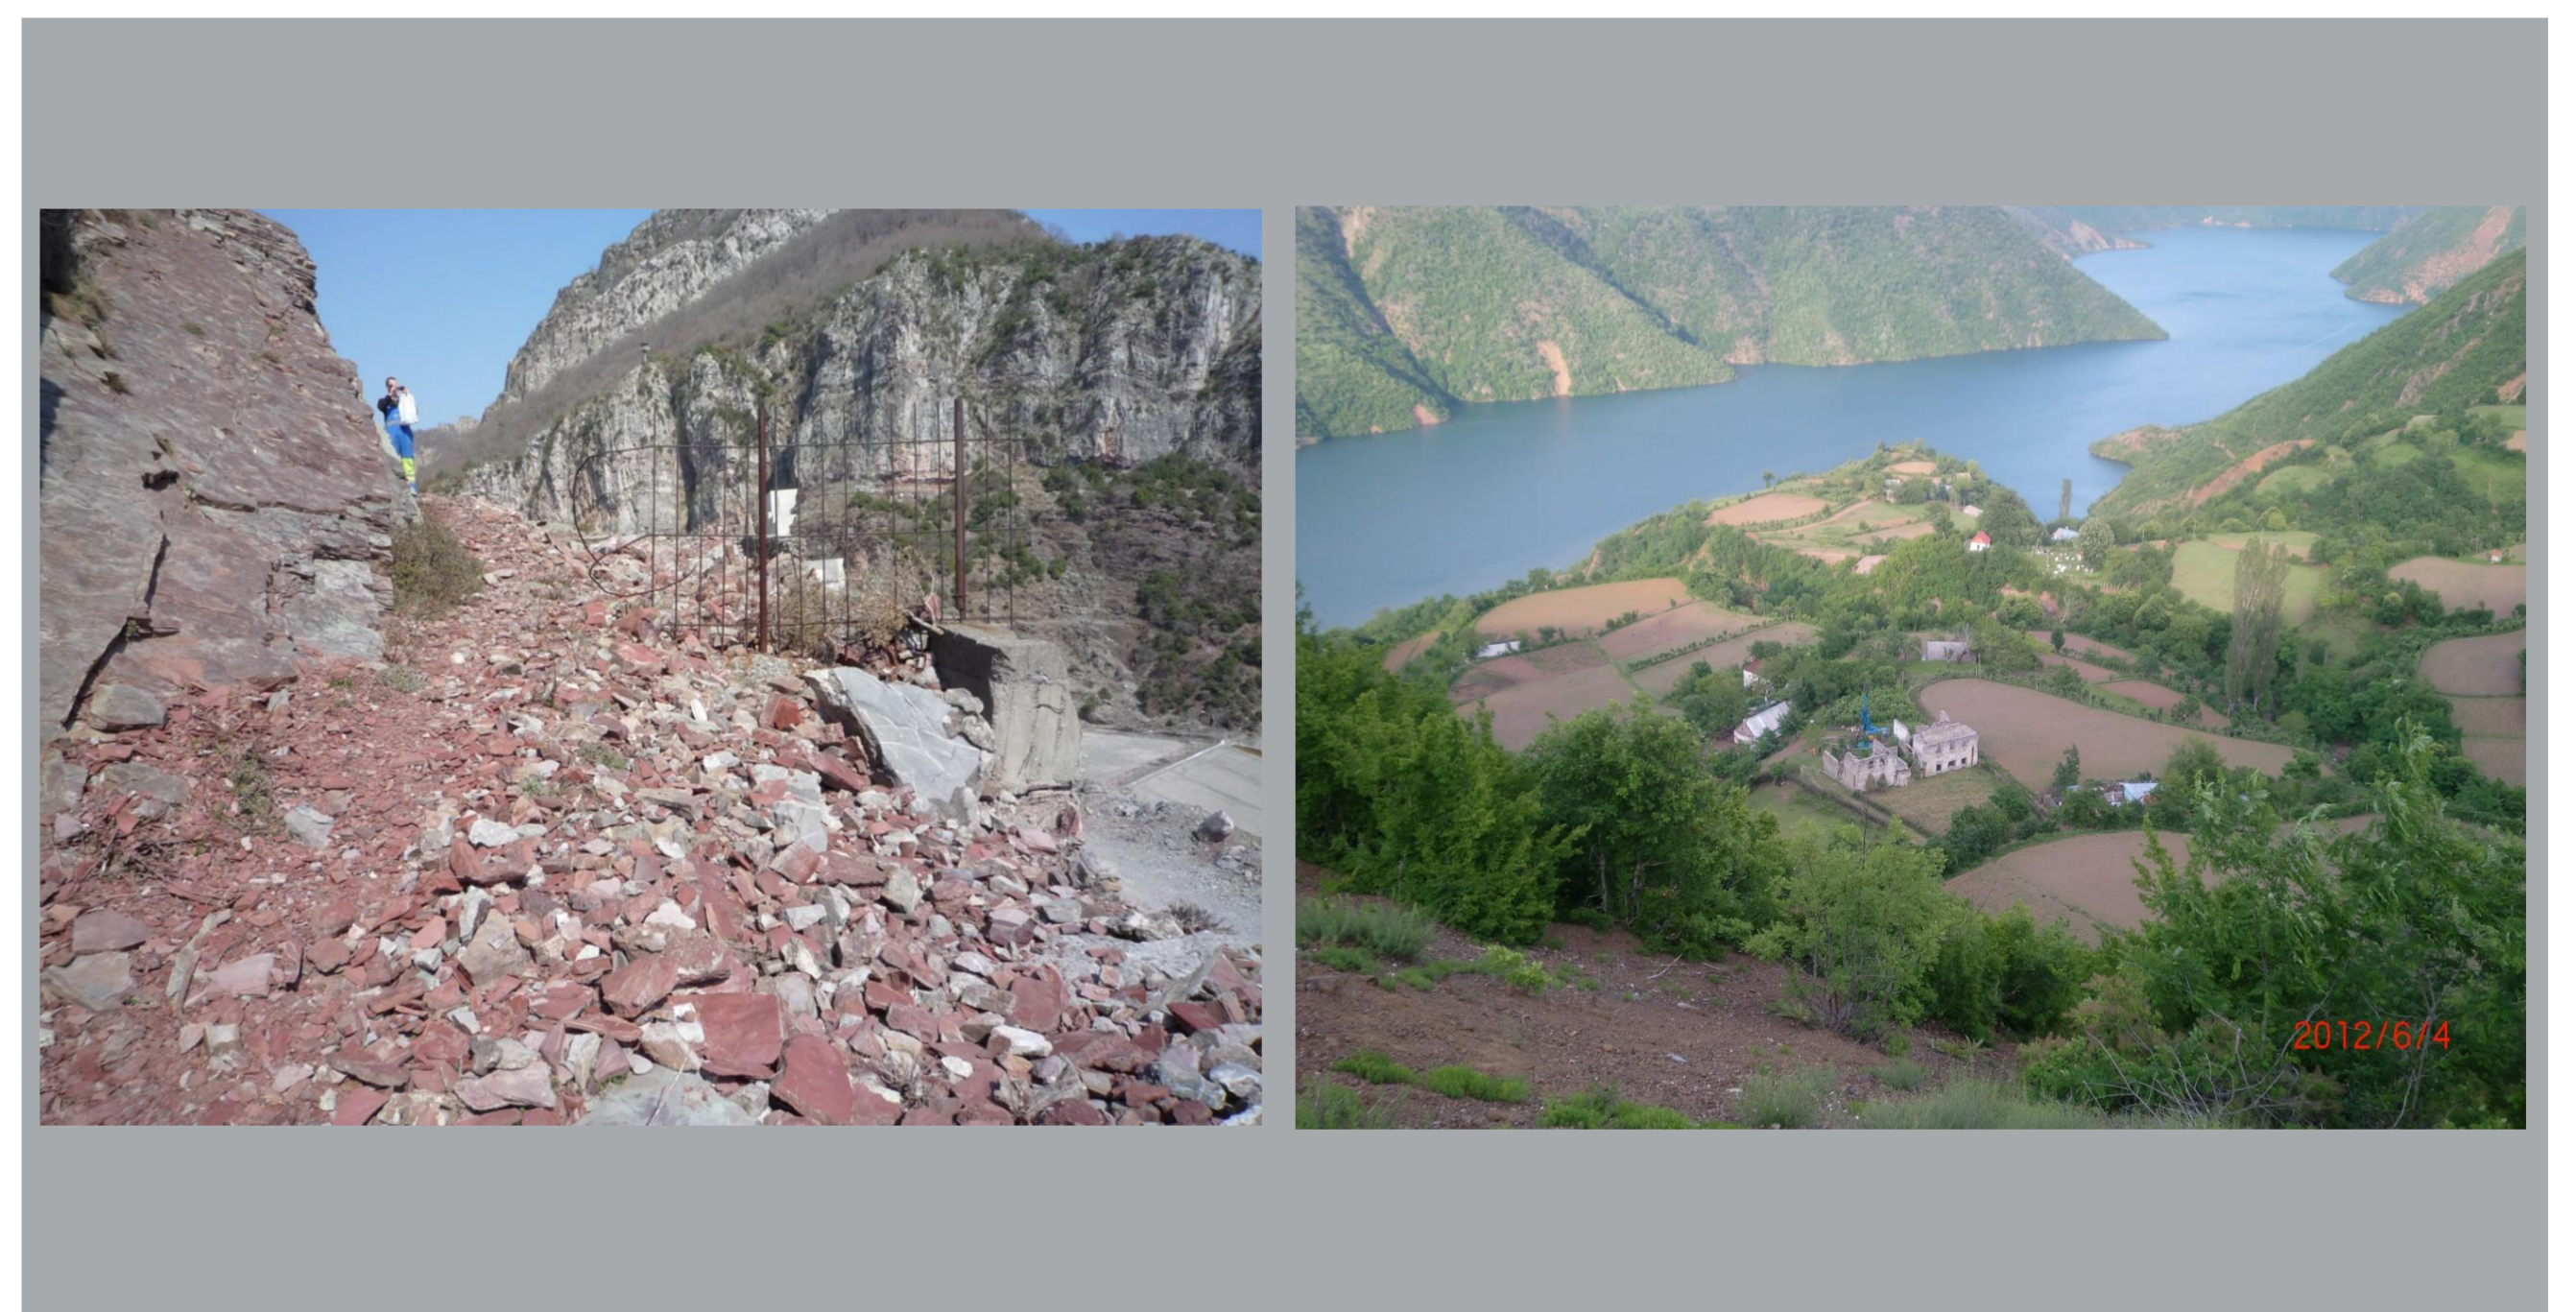
Fig. 3: Geohazards present at Komani and Fierza dams' area

- Rockslides and landslides, present on the slopes near all above-mentioned dams.
- Erosion phenomena, from surface waters and the waters of the Drin river itself.
- Leakage of water from the reservoir of each dam under the foundation of the dam or from the side slopes.
- Filling of reservoirs with alluvial deposits, (sedimentation).

After a careful study and evaluation process of the current condition of the large dams built over the Drin River cascade, their monitoring and maintenance, as well as their safety assessments and geohazard aspects the authors have concluded the following main geological hazards:
