# PV Plant - New potentials in Vau i Dejes HPP, Albania

Author(s): Fatjon Shaha, Arjan Jovani

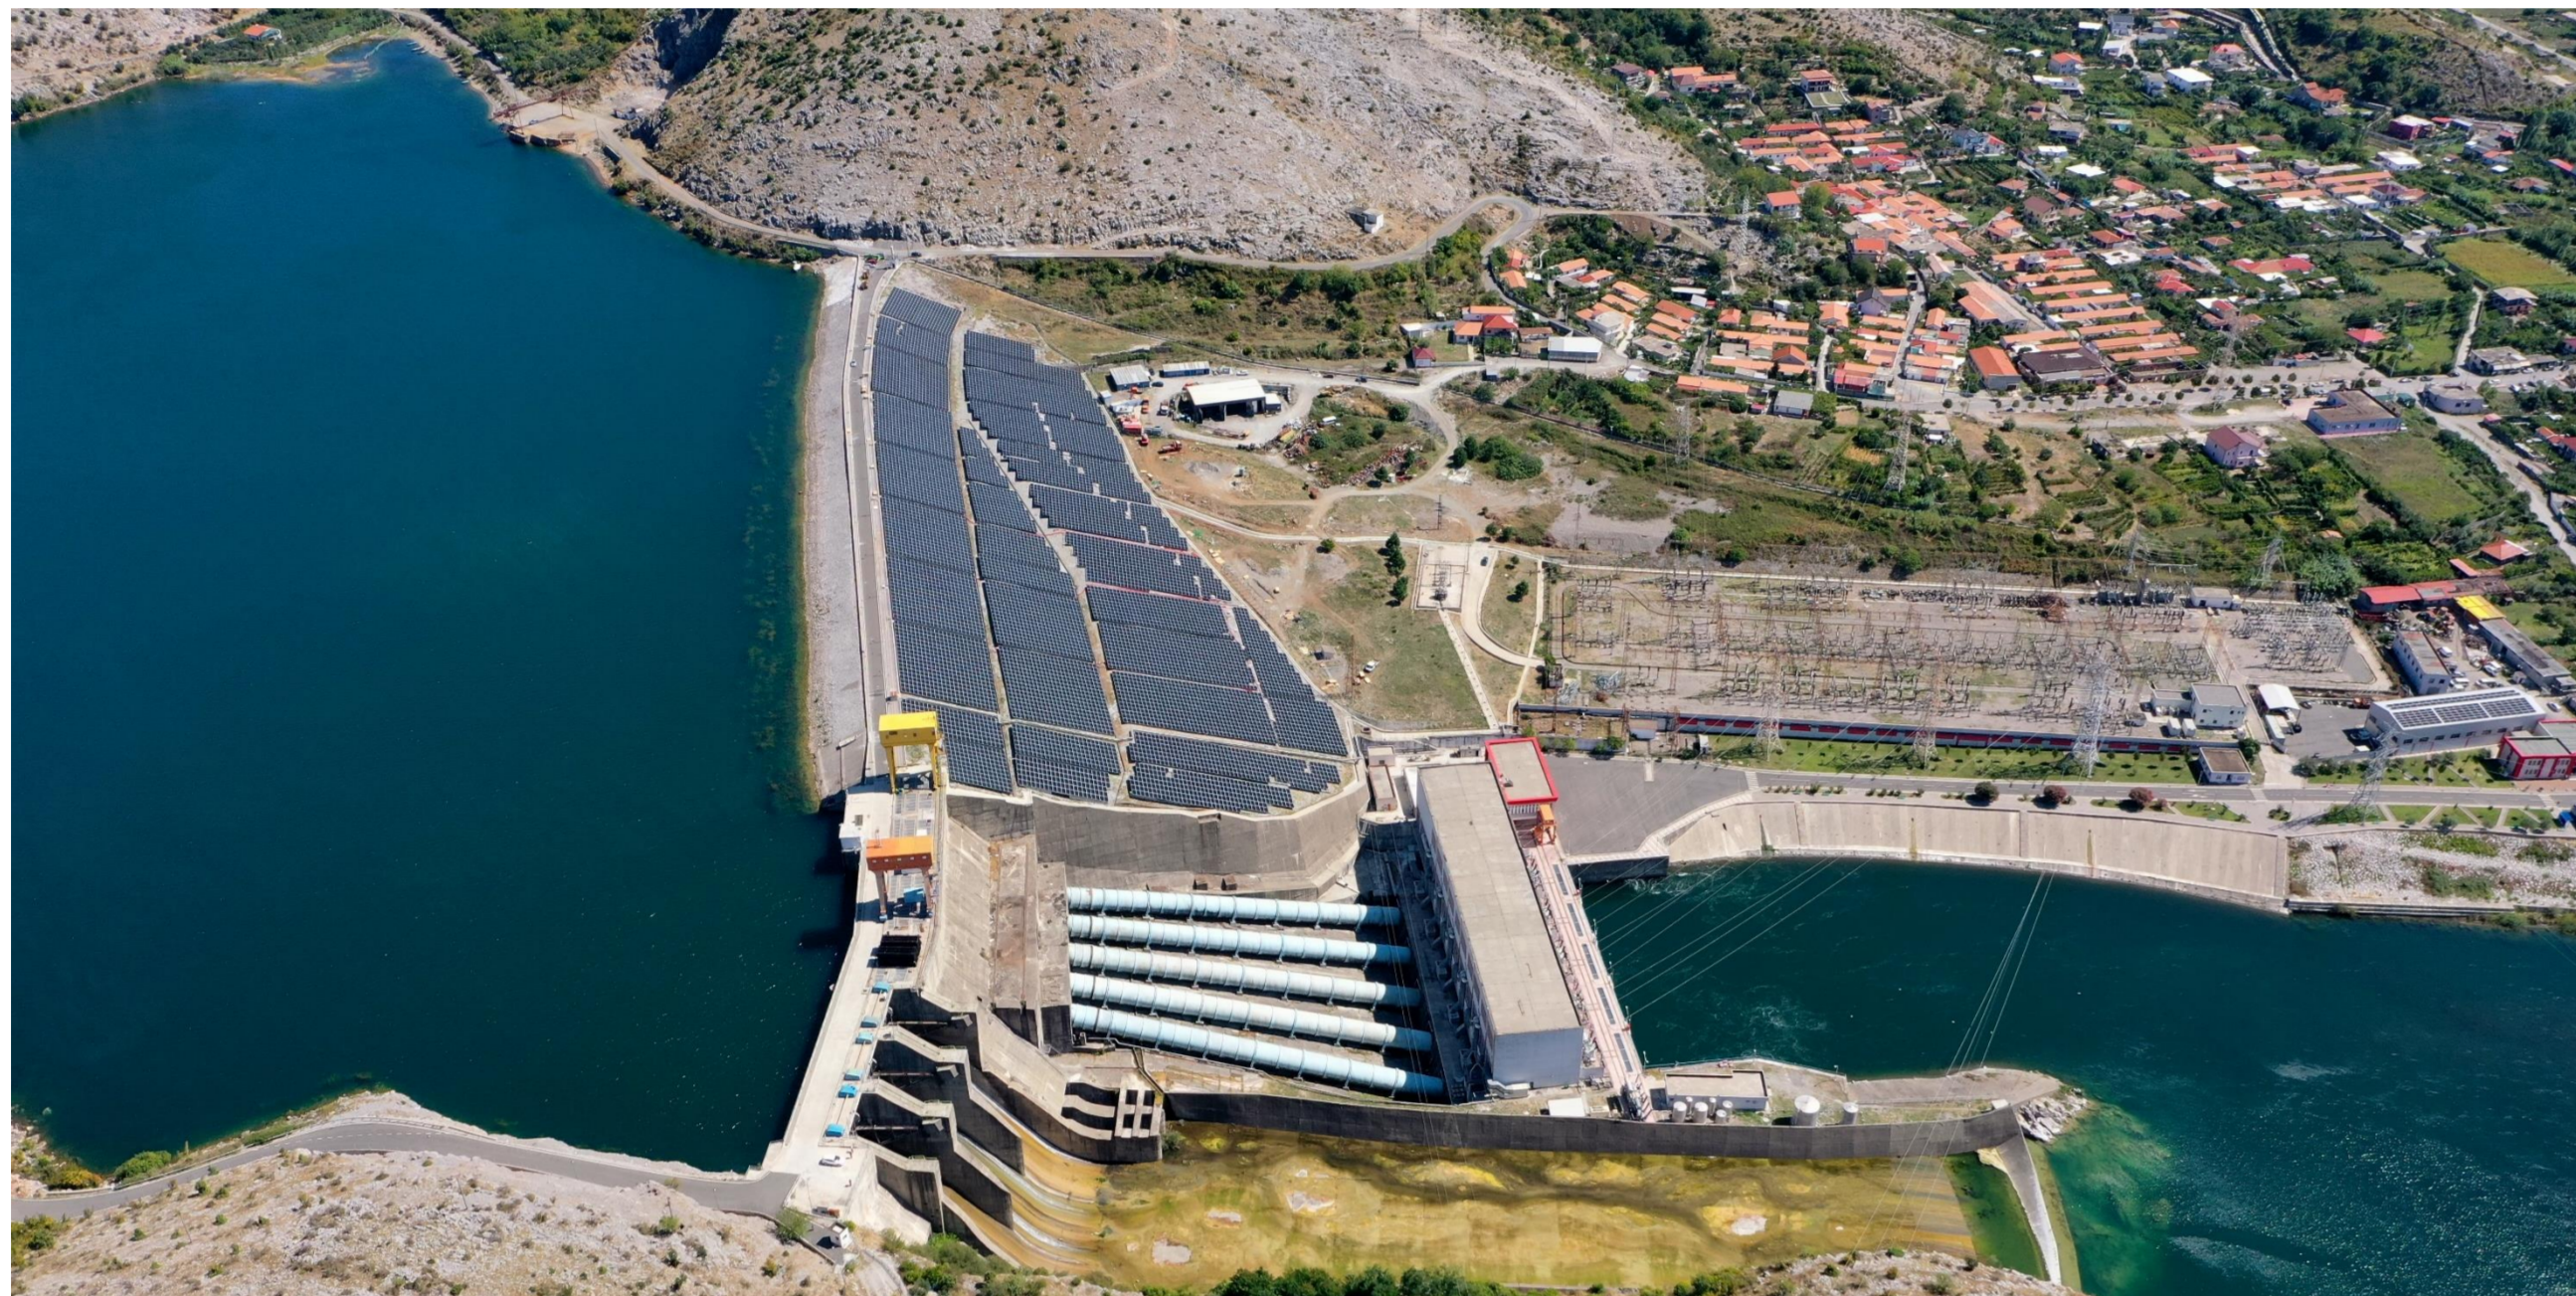
Figure 1: View of PV Plant on the downstream face of Qyrsaq Dam

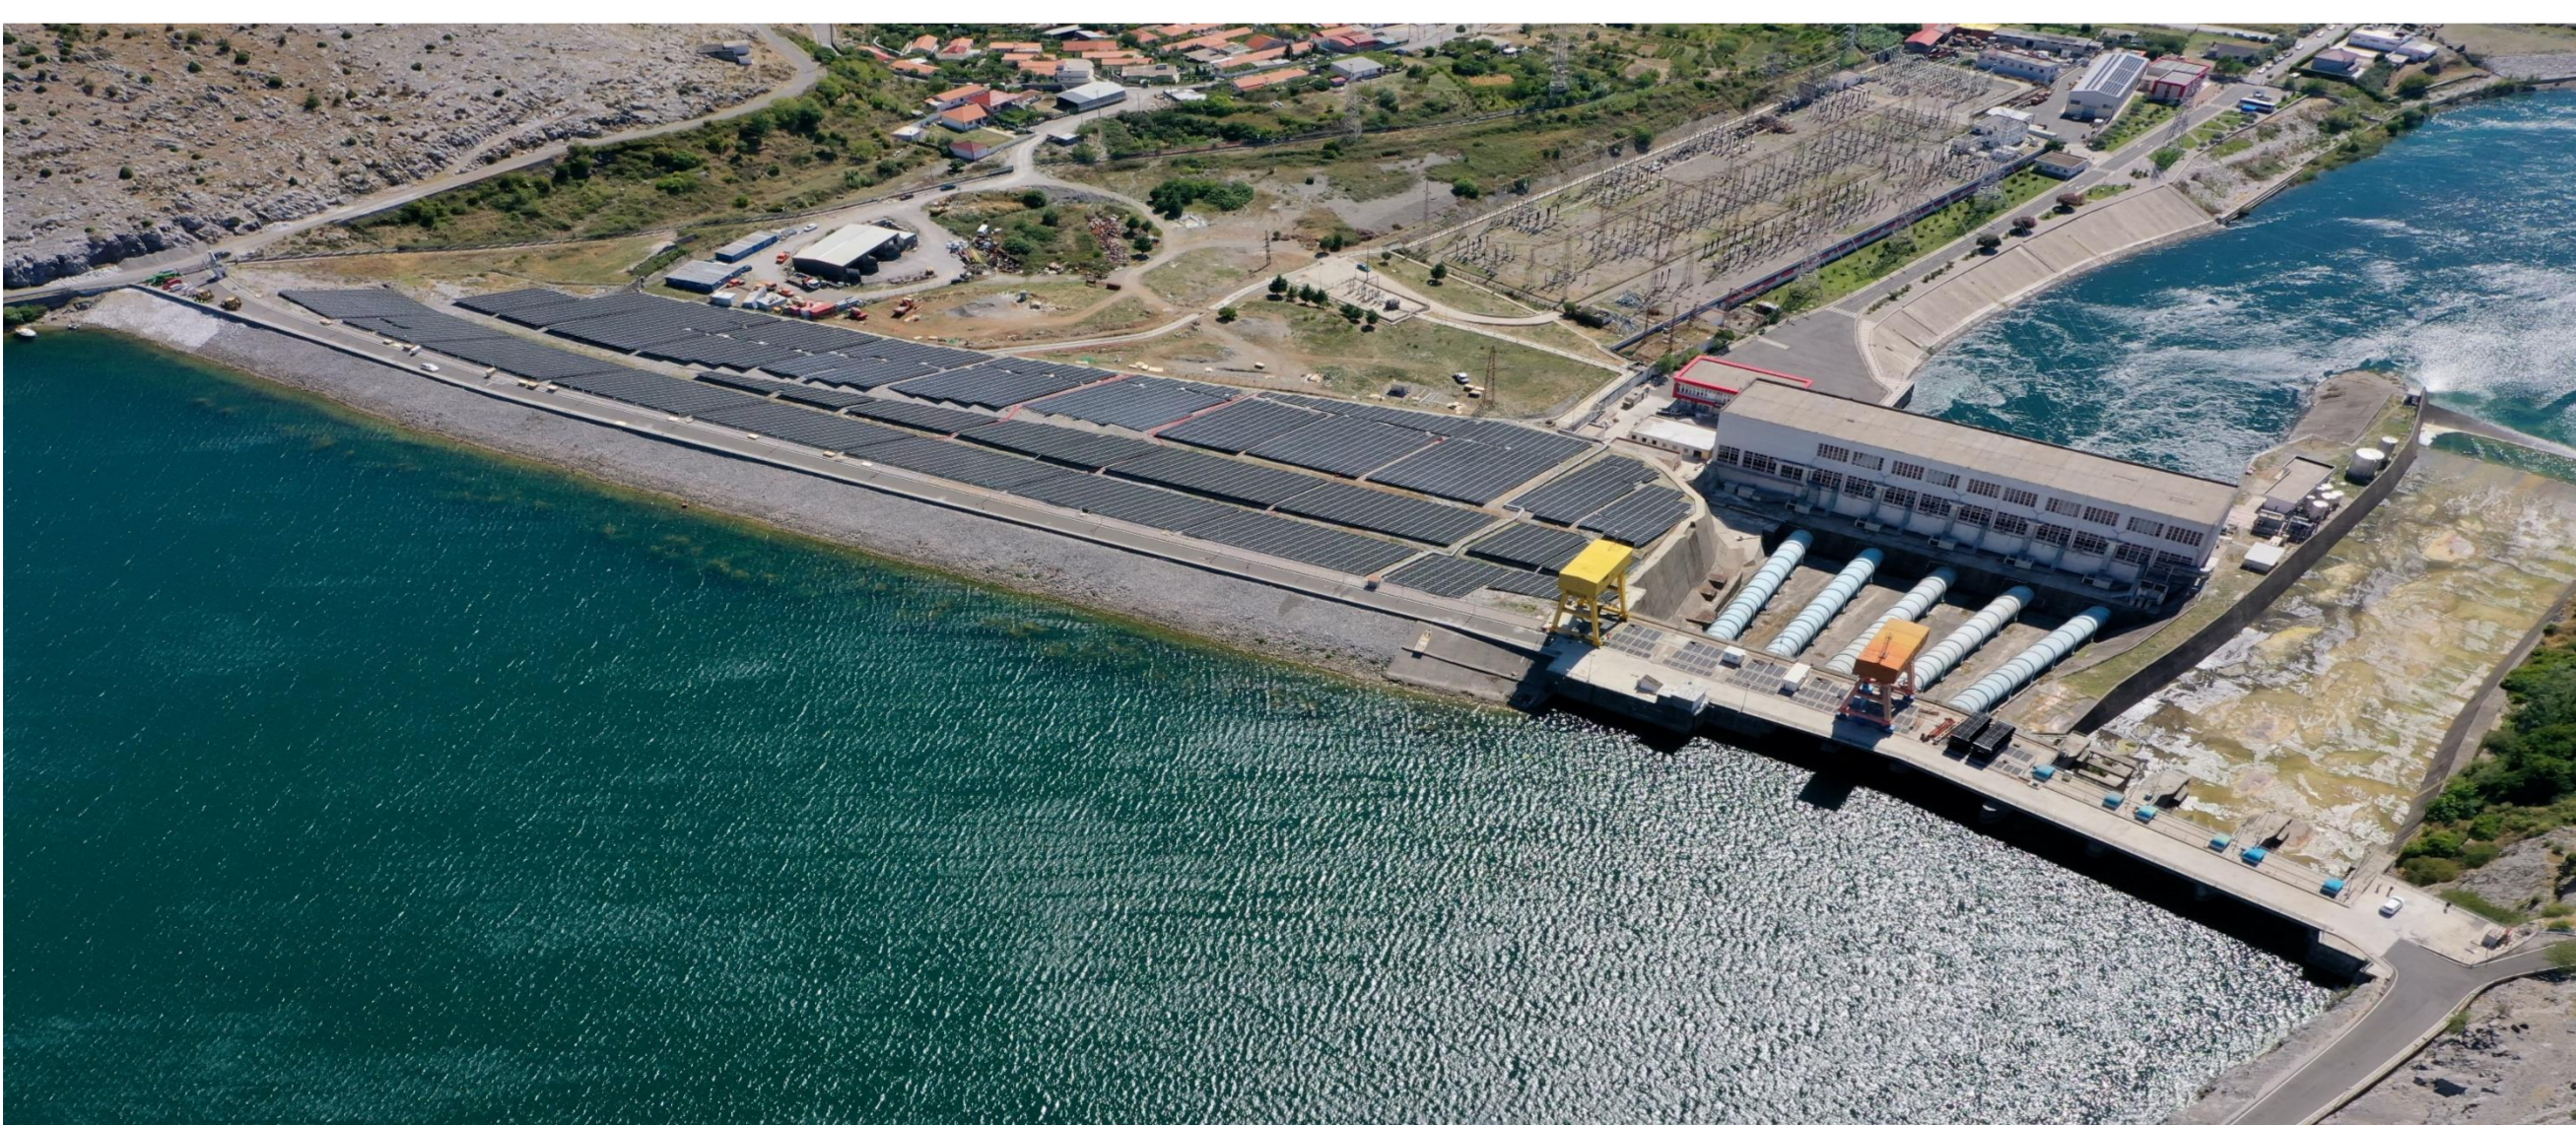
Figure 2: View of PV Plant in Qyrsaq Dam from Upstream

The installation method considers structural safety, ongoing dam monitoring, and access to monitoring instruments while minimizing the impact on the dam through spacing, ventilation,

panel placement, monitoring system, ease of movement, and the use of lighter materials.

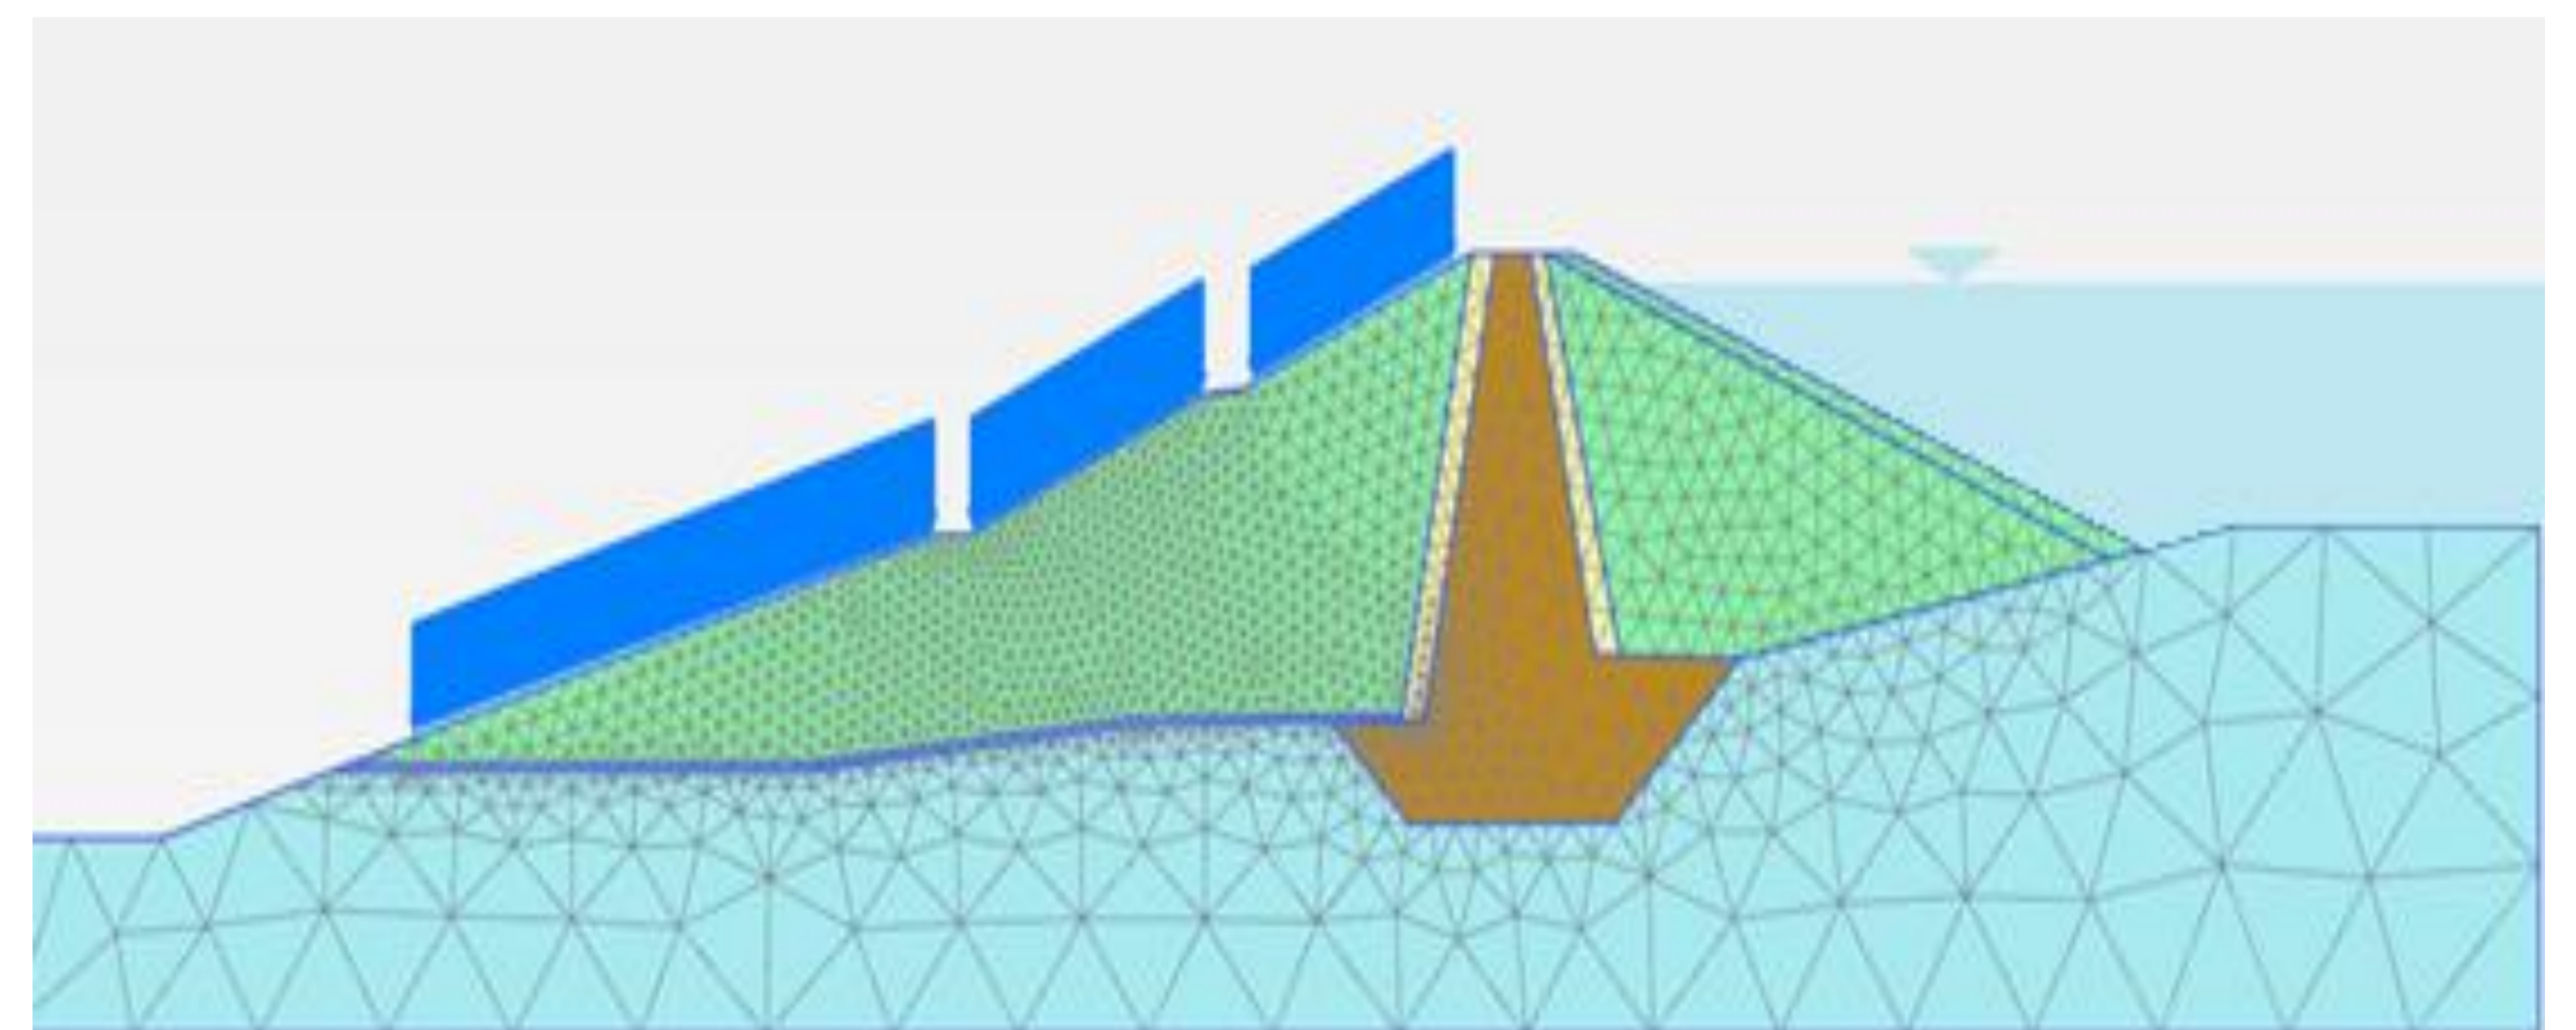
Figure 3: Mathematical model for additional load of PV plant on Qyrsaq Dam

To analyze the stability, stress state, and deformations of the dam, advanced engineering Finite Element software, PLAXIS 2D, was employed under plane stress conditions. This powerful software enabled a detailed assessment of the structural behavior of the dam in response to the additional loads imposed by the PV panels. By utilizing PLAXIS 2D, engineers were able to simulate and analyze the complex interactions between the dam structure and the PV system, accurately predicting stress distribution and deformations. This analysis provided critical insights into the dam's stability and ensured that the design and installation of the PV plant were carried out in a manner that maintained the structural integrity of the dam.

In assessing the stability of the downstream slope of the dam, a comprehensive analysis was conducted, taking into account the saturation line between the upstream face of the dam and the filter and drainage layer beneath the downstream shell.

The results of the analysis revealed that the installation of the PV panels did not have a detrimental effect on the stability of the dam. Furthermore, the safety reliability index of the dam, determined by considering the average safety factor and a standard deviation indicator, remained within the limits specified by technical standards. This outcome confirms that the integration of the PV panels on the dam is compatible with the required safety measures and ensures the continued reliability of the dam structure.
