Improvement of Operation, Maintenance and Safety of 6 large Dams in Kosova

F. Shaha; A. Jovani; L. Zani
ALBCOLD; LORENCO&CO, Tirana, Albania

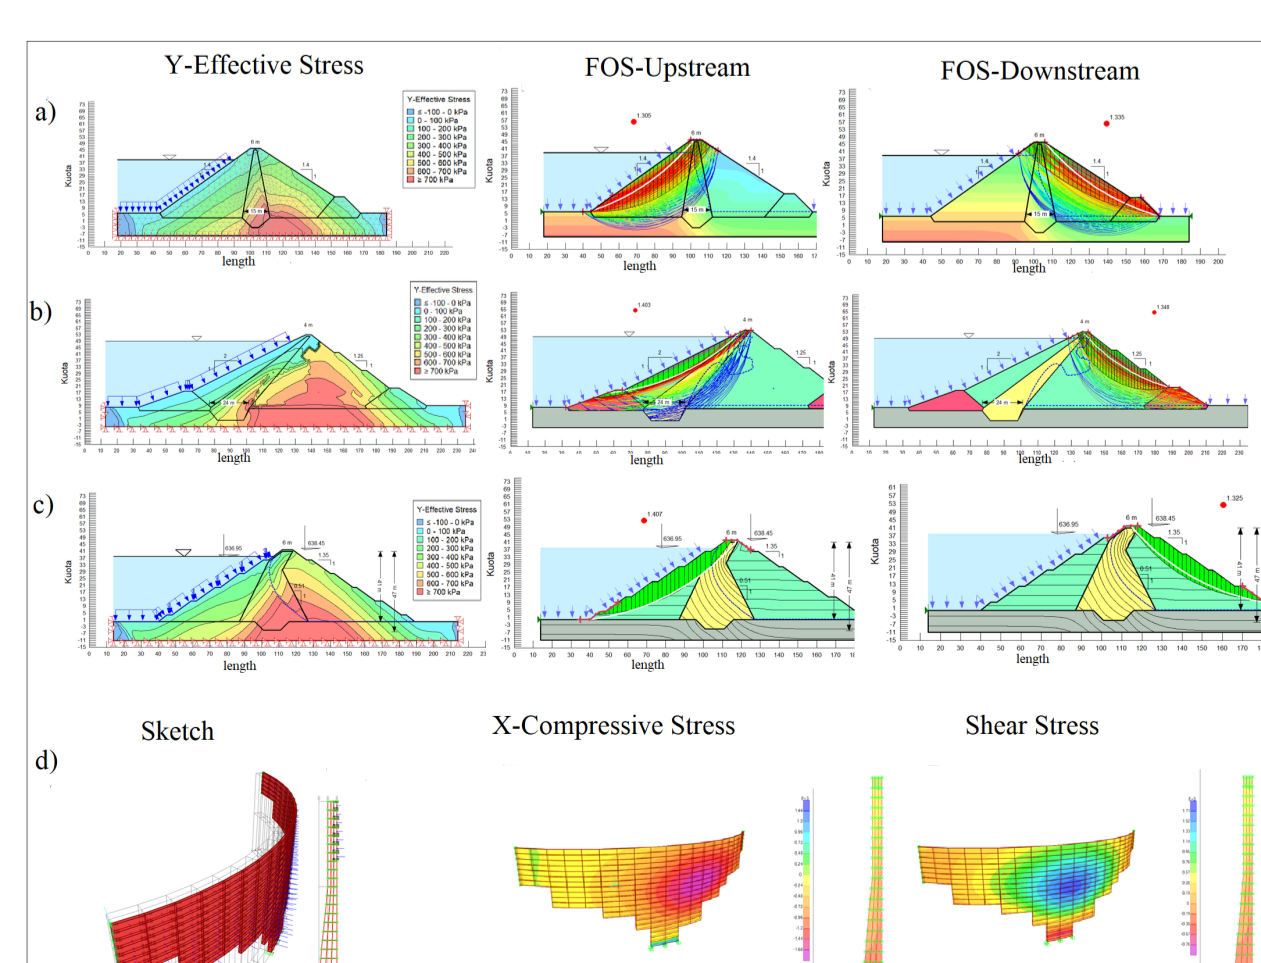
Stability analyses of four large dams

Our team conducted a thorough safety assessment of four dams using geotechnical and seismic data. We analyzed dam stability under different conditions, including earthquakes with recurrence periods of 475 and 975 years. Our Static and Dynamic Stability Analysis employed various design criteria, including seepage analysis and effective stress evaluation.
